National Dam Inspection Program

UPPER DAM

CENTRE COUNTY, COMMONWEALTH OF PENNSYLVANIA

PHASE I INSPECTION REPORT

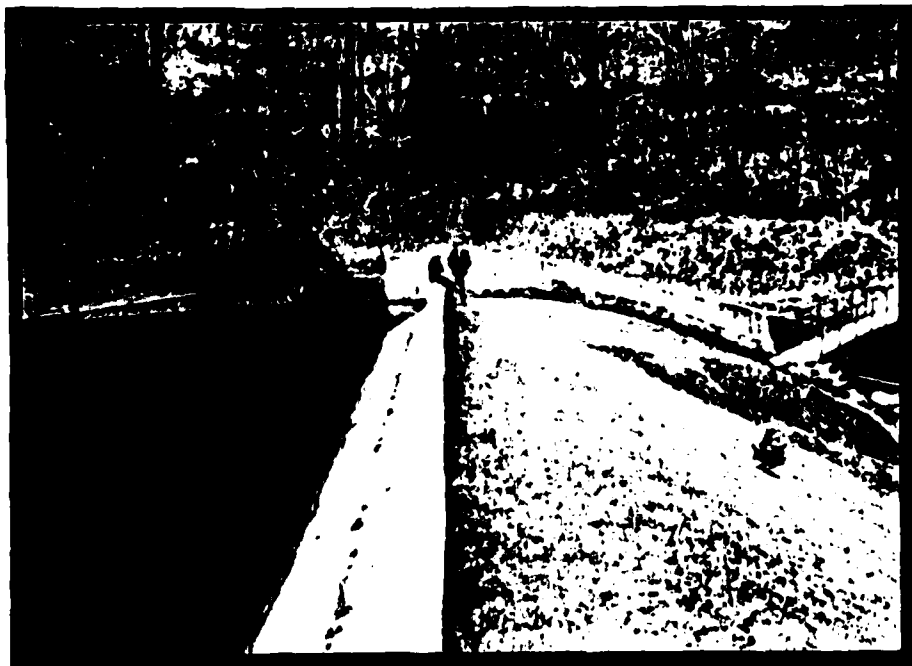
Photo 2 Dam Crest looking toward principal (and emergency) spillway at left abutment.

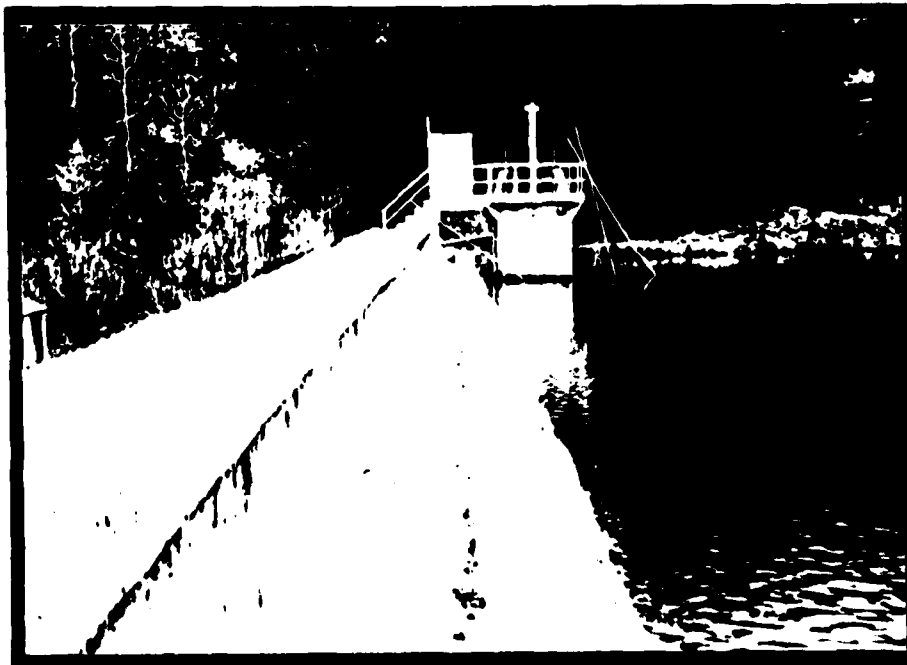
(2) Upstream Slope: The upstream slope of the embankment is paved with a concrete slab that lies below a masonry slab that has been coated with concrete. The general condition of the slab is good, though some cracks were noted and some minor spalling was observed. No large gaps or erosional distress was observed. No depressions or settlement of the slab was observed and there was no indication that the slab has been undercut.

Photo 4 Upstream Slope showing gate house,
parapet wall and upstream slope protection.

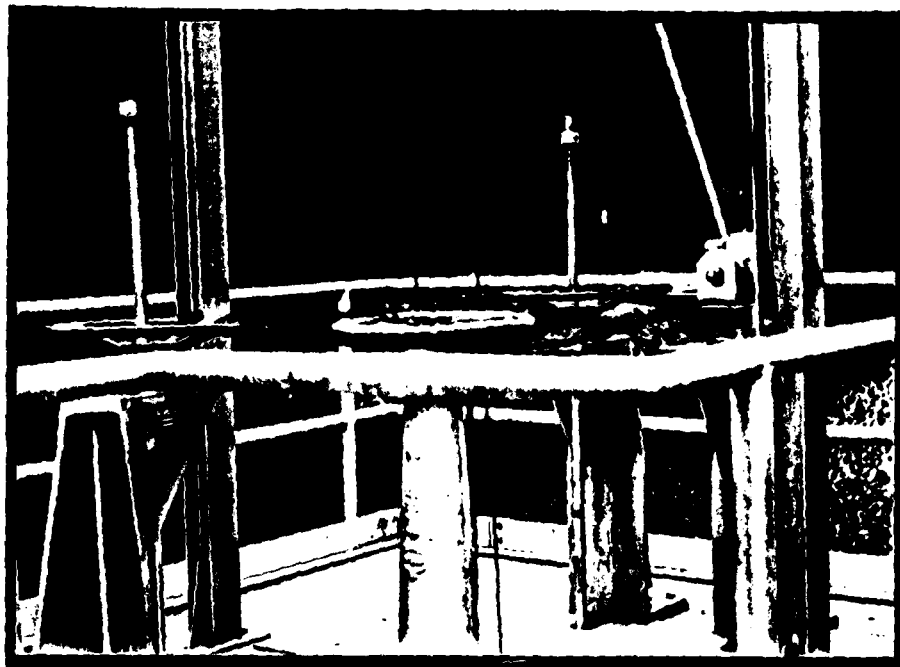
(2) Intake Structure: The inlet end of the pond drain was not observed due to the high reservoir pool level. However, the pond drain controls are located on the gate house. The handwheel controlling the pond drain was partially opened and discharge was observed at the outlet end of the pond drain conduit. The valve was then closed and operation was observed to be satisfactory.

Photo 5 Valve Controls atop gate house.

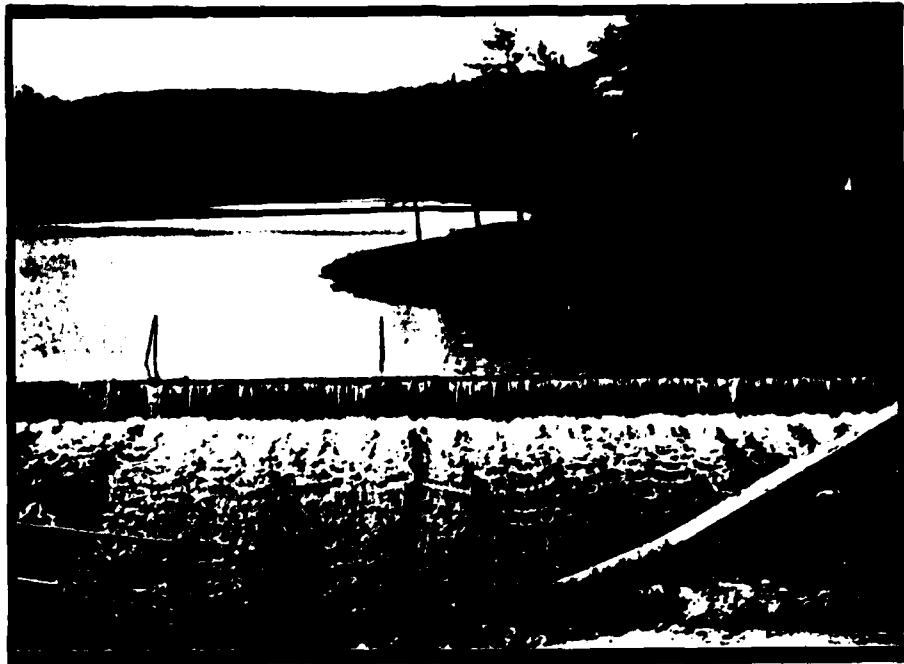
(1) Weir: The flow control for the principal spillway is a sharp crested weir that is formed by steel flashboards located between the training walls of the principal spillway chute. The weir was 2 feet high and 54.5 feet long across the crest. A few sticks and brush debris were noted trapped on the edge of the weir but did not provide any significant disturbance to flows over the weir.

Photo 7 Principal (and Emergency) Spillway Crest.
Note flashboards and bent bar trash
carriers.

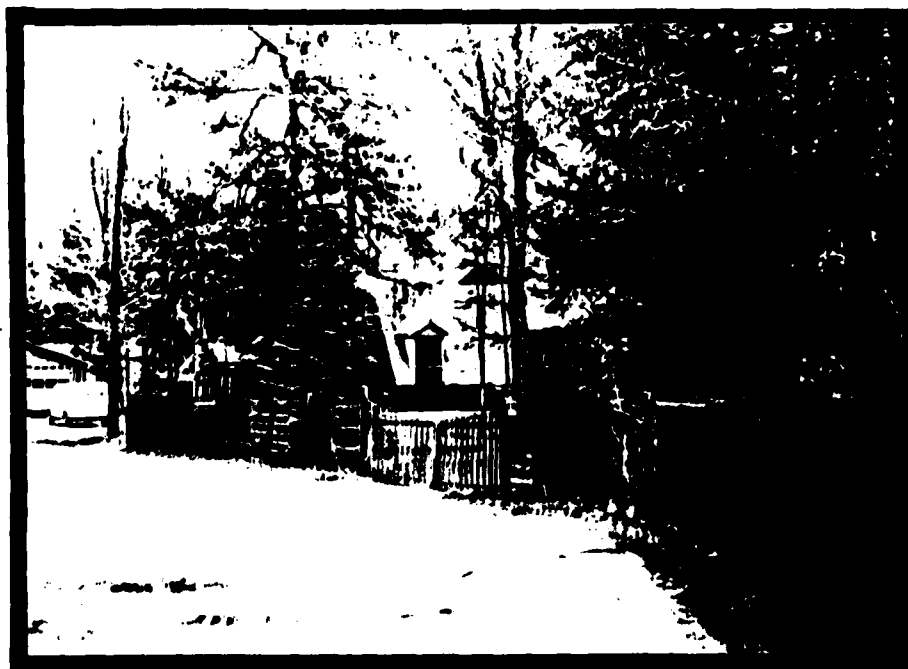
Photo 10 Downstream Hazards. Inhabited dwellings located on Cold Stream floodplain approximately 2000 feet below Upper Dam.
